Innovative methods of water hyacinth removal in tropical coastal wetlands – cutting the costs

Vern Veitch¹, Damien Burrows¹ and David Hudson²

¹Australian Centre for Tropical Freshwater Research, James Cook University, Townsville, Queensland 4811, Australia

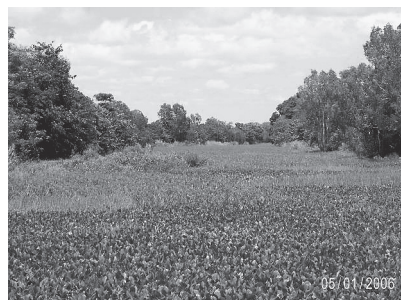
Figure 1. Lagoon 1 during brine spraying.

Bankside spraying of plants binding the weed mats to the bank was trialled prior to the end of the wet season. 120 litres of Roundup® Bio-active was applied at a rate of 13 mL L⁻¹ taking 23 man-days at a total cost of \$9000. After an initial trial of aerial brine spraying that did not seem to affect water hyacinth, ground-based field trials were undertaken to determine appropriate application strengths and volumes. Brine spraying was subsequently undertaken in the most downstream lagoon using a helicopter fitted with spray booms for agricultural spraying. (Figure 1) The effective swath of the booms was 11 metres with 50 Teejet air injected nozzles on the booms. Ten loads of 450 litres per load containing about 100 kg of salt per load were applied over roughly 10 ha. The operation took three hours and cost \$5000. While the observed impact on the water hyacinth was minor the brine had a greater effect on the secondary plant infestation binding the mat surface, reducing the integrity of the weed mat.

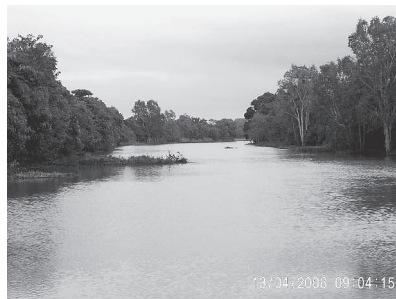
Figure 2. Lagoon 1 showing weed flushed out by a small flood after brine and herbicide treatment.

had also occurred, saw approximately 5 ha of weed mats flushed downstream (Figure 2). This indicated the success of the combined herbicide and brine-spraying program to break the integrity of the tightly held weed mats. The operation saved an estimated 10 days of mechanical harvesting that would have cost in the order of \$30,000. Brine spraying can be effective in areas where aerial herbicide spraying is restricted and should be considered for future projects depending on the site, species and density of the weed infestation. The amount of salt used on the dense weed mat had no effect on water quality and it is probable that most brine remained on the weed mats, and did not reach the water surface anyway.

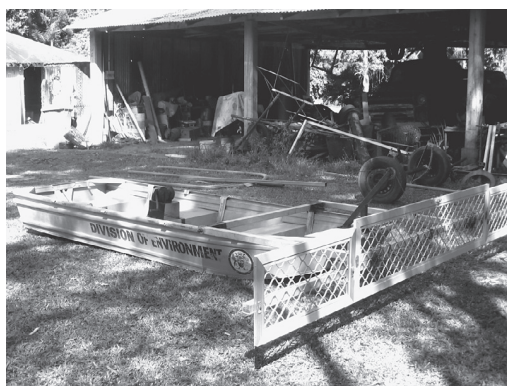
Figure 3. Aquadozer fitted with wings.

excavator was positioned at one of two fixed points in each lagoon, created by hardening work platforms with rock. As the floating harvester moves slowly, this created a logistical problem of moving weed mats to the excavator. To overcome this problem we trialled the use of small boats to help move mats to the waiting excavator, and to access areas around snags. These boats were trialled in various combinations, including working in pairs with rope between them to pull weed mats, and also with the use of a security door fitted to the front of a boat in order to improve their ability to push mats to the excavator.

costing \$800. The small boats fitted with mesh rakes were then able to push much larger weed mats than those without rakes (Figures 3 and 4). Aquadozers were also effective in pulling weeds from the banks and in collecting smaller patches of weeds that neither the weed harvester nor unmodified boats were unable to clean up.
